- Carefully check sealing and condition of rubber sleeves for ball joints on tube shocks of front and rear axle.

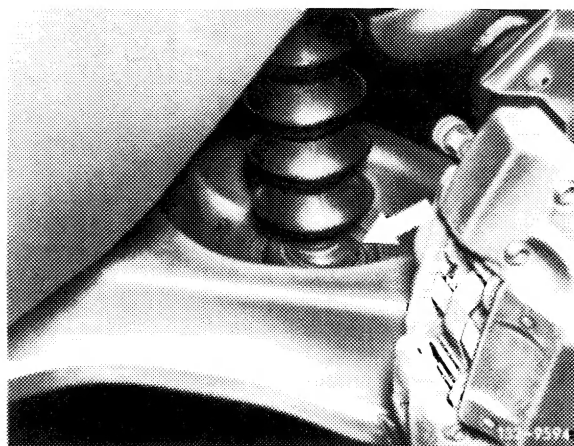
Ball joint on rear axle

Note: In the event of a leaking rubber sleeve, replace respective joint immediately since penetrating dirt will result in early destruction of joint. The rubber sleeve alone cannot be replaced.
